Technical Note:

Condition Assessment of the Deteriorated Reinforced Concrete Bridge

Wijaya, G.B.^{1*} and Pacuribot, N.²

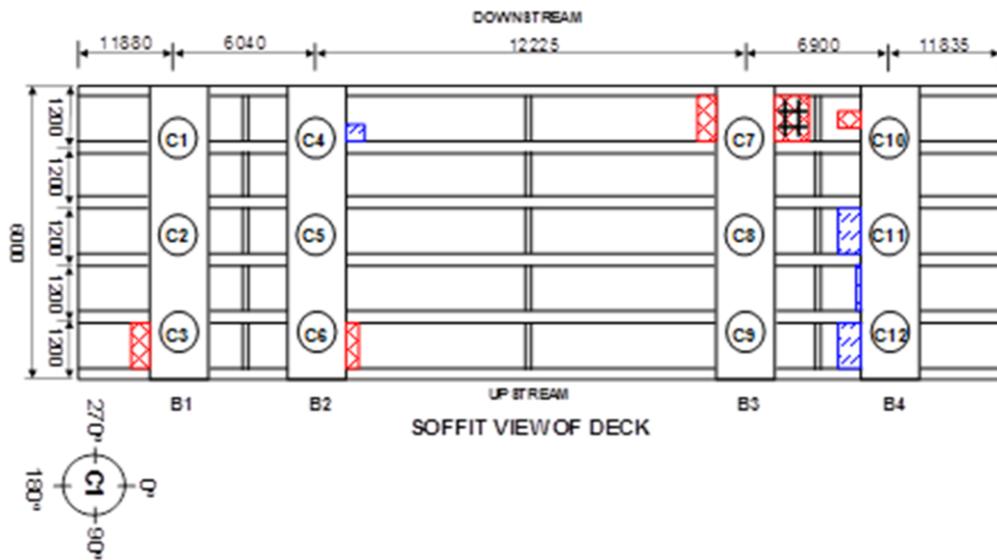
Figure 2b. Bridge Deck Mapping and Orientation

Generally, unsound (i.e., delaminated) areas were in the immediate proximity of cracks in the concrete columns. This test was conducted on the accessible surfaces of the Bridge columns and beams only. Most of the concrete in the middle length of columns were found delaminated. Significant conditions detected in reinforced concrete structures during mechanical sounding (Acoustic Impact Test) are plotted in mapping shown in Figures 2b to 2d.

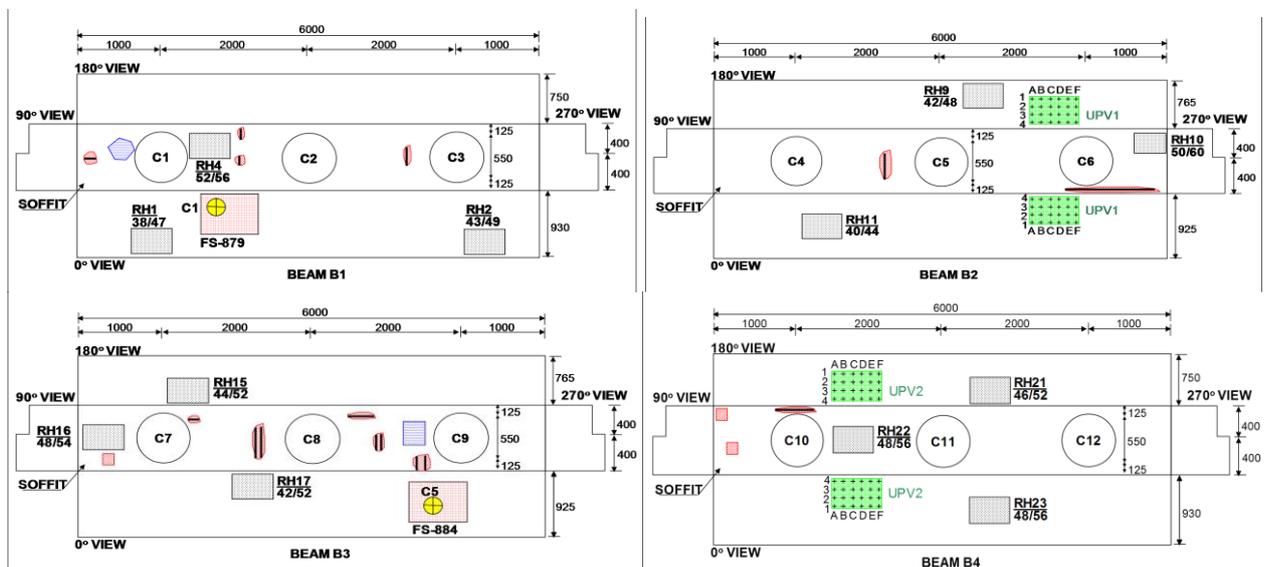
Figure 2c. Bridge Beam Mapping

The beam concrete seemed to be in good condition. Isolated and small areas of delaminated concrete and exposed rebars were found. The underside of the deck slab also seemed to be in good condition as well, except some localized minor delamination, spalling, and exposed rebar.

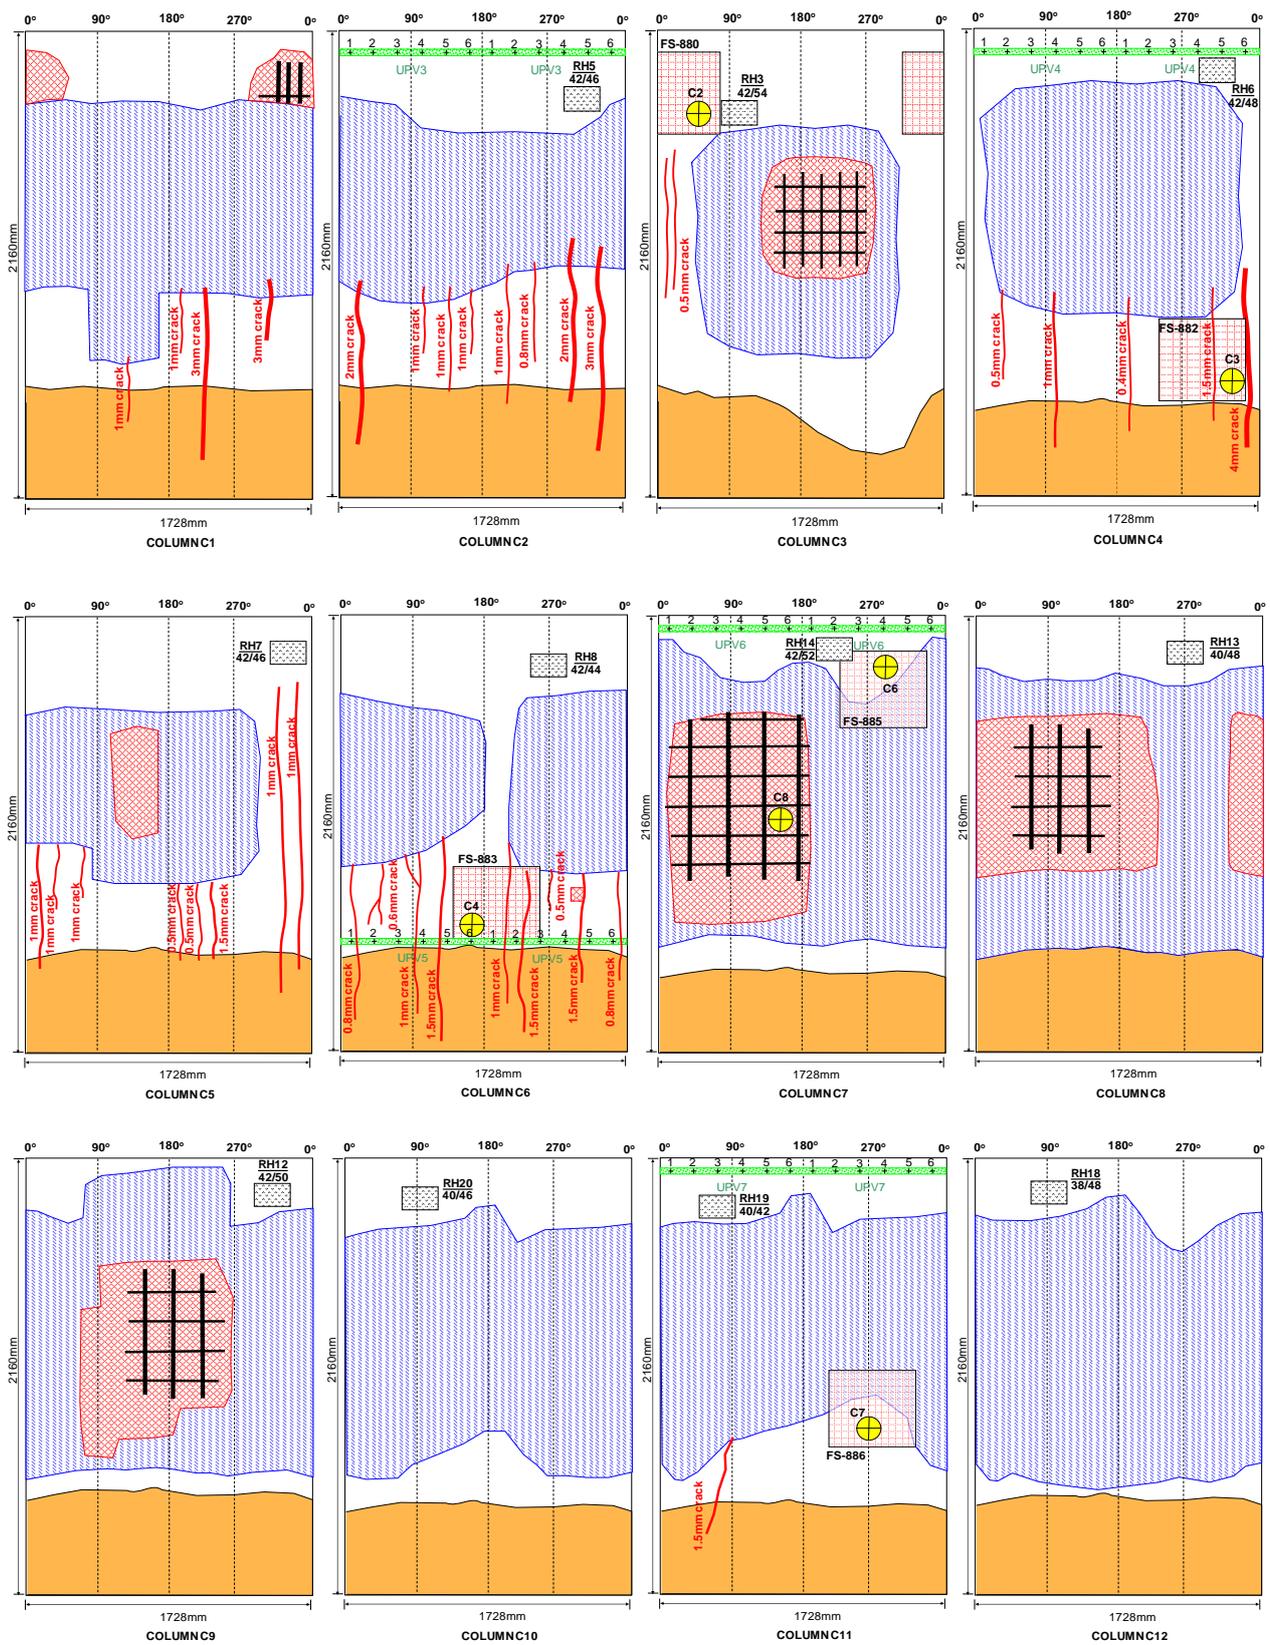
Figure 2d. Bridge Column Mapping

The column concrete within the top 300mm from the beam soffit was generally in good condition. The concrete in the next 1200mm was in a very bad condition which mostly appeared to suffer from cracks, delaminations, and concrete spalling. The bottom part of the column, which is approximately 500mm from the pile cap, was full of barnacles and appeared to be in good condition.

Areas of internal separations (i.e. delamination) were detected at numerous locations on columns between 500 to 1700 mm high from the pile cap, as shown in Figure 2d. Generally, these delaminated areas were associated with embedded reinforcing steel corrosion. Some detected delaminations are shown in Figures 4a and 4b.

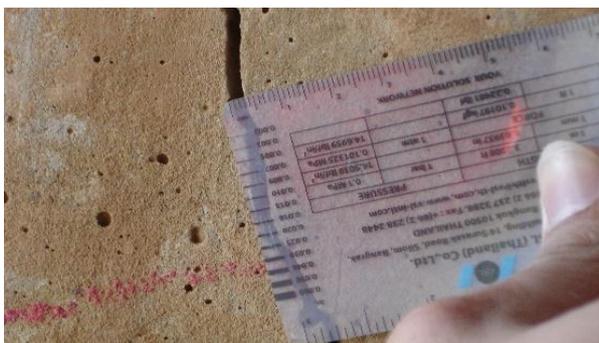
Cracking observed at the subject structures typically took the form of fine to wide cracks. At a few locations however, cracking though was observed to be faulted (i.e. uneven crack shoulder edges). Faulted crack patterns observed were typically associated with stresses created during the embedded metal corrosion process within concrete as shown in Figure 3.

Figure 3. Three mm Crack Found on Column C1

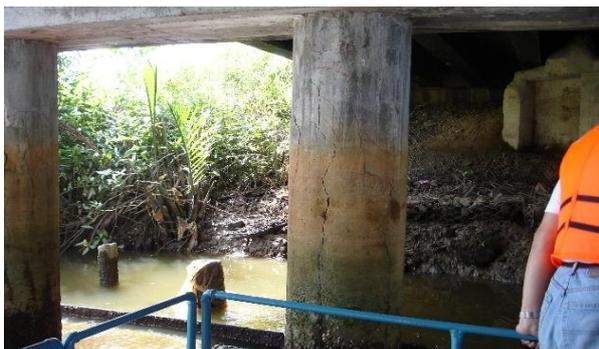
Figure 4a. Delamination Detected on Column C2

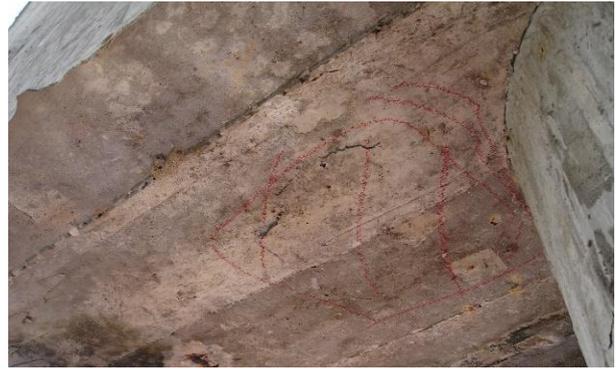
Figure 4b. Delamination Detected on Beam B1

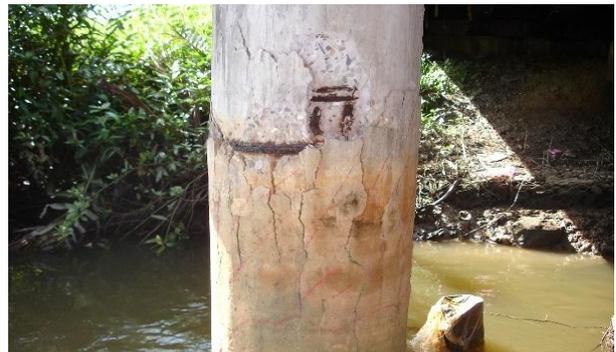
The spalling observed appeared to be primarily related to the embedded reinforcement corrosion. Concrete spalling exposing severely corroded rebars were found in many locations in the columns, showing serious concerns in its structural integrity. The exposed reinforcements (rebars) found on the beams and deck were mainly due to insufficient concrete cover [$\sim 10\text{mm}$] or debris which was not cleared during concrete placement. Some of the observed concrete spalling were shown in Figures 5a to 5d.

Figure 5a. Cracking, Delamination, and Spalling with Exposed Rebar on Column C1

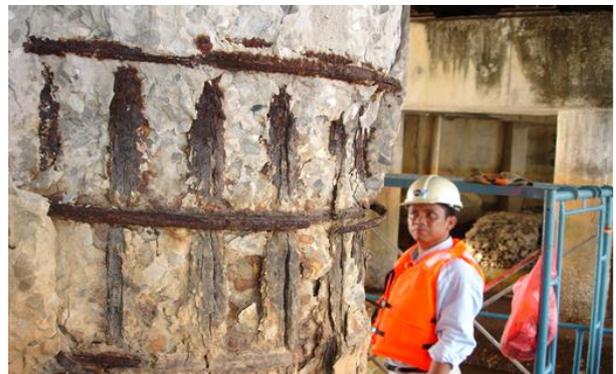
Figure 5b. Concrete Spalling Exposing Severely Corroded Rebars on Column C9

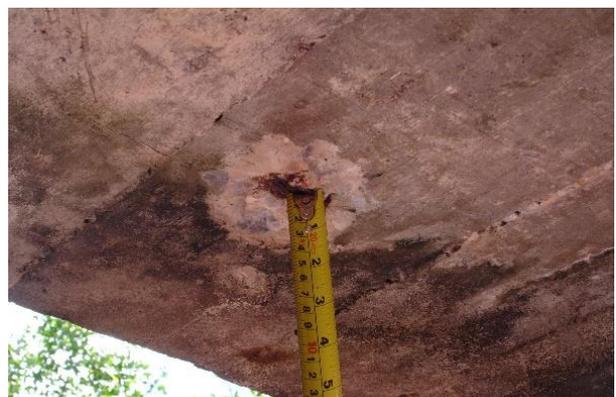
Figure 5c. Exposed Rebar with 10mm Cover on Beam B1 Soffit

The concrete cover for column ranged from 40 to 90mm, whereas the concrete cover for the beam was noted to be approximately 40mm. However, some localized areas exhibited concrete spalling due to corrosion with concrete cover of approximately 10mm only. From the water stain found on the columns during the site investigation, it is noted that the tidal splash zone covers approximately 1300 to 1400mm column height and it is these areas that exhibit the most severe concrete damage.

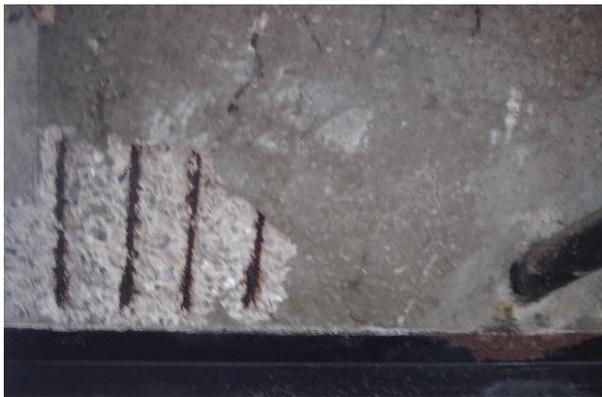
Figure 5d. Concrete Spalling with Exposed Corroded Rebars on Deck Soffit

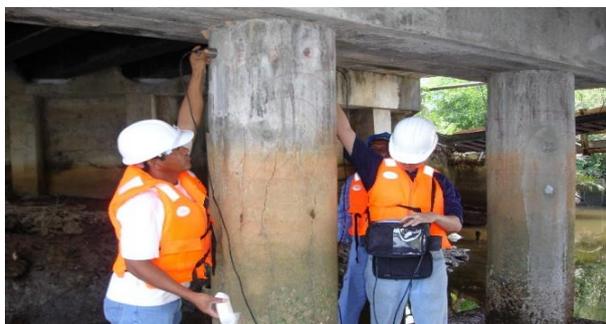
Figure 7b. UPV Test on Column C2

Stable results were obtained for the beams and most of the columns (with sound concrete) which ranged from 3.20 to 3.61 km/s. UPV Test on Column C2 [UPV 3] and Column C6 [UPV 5] gave very low average reading, which were 1.64 and 0.90 km/s, respectively. These very low results suggested that there could be excessive voids between the two transducers, either caused by the poor compaction of concrete or the concrete are beginning to experience internal separation. In general, the results of these tests show that the concrete samples were in good condition, except for the Columns C2 and C4 where the reading shows very low value. The results of UPV Test are presented in Figures 8a and 8b.

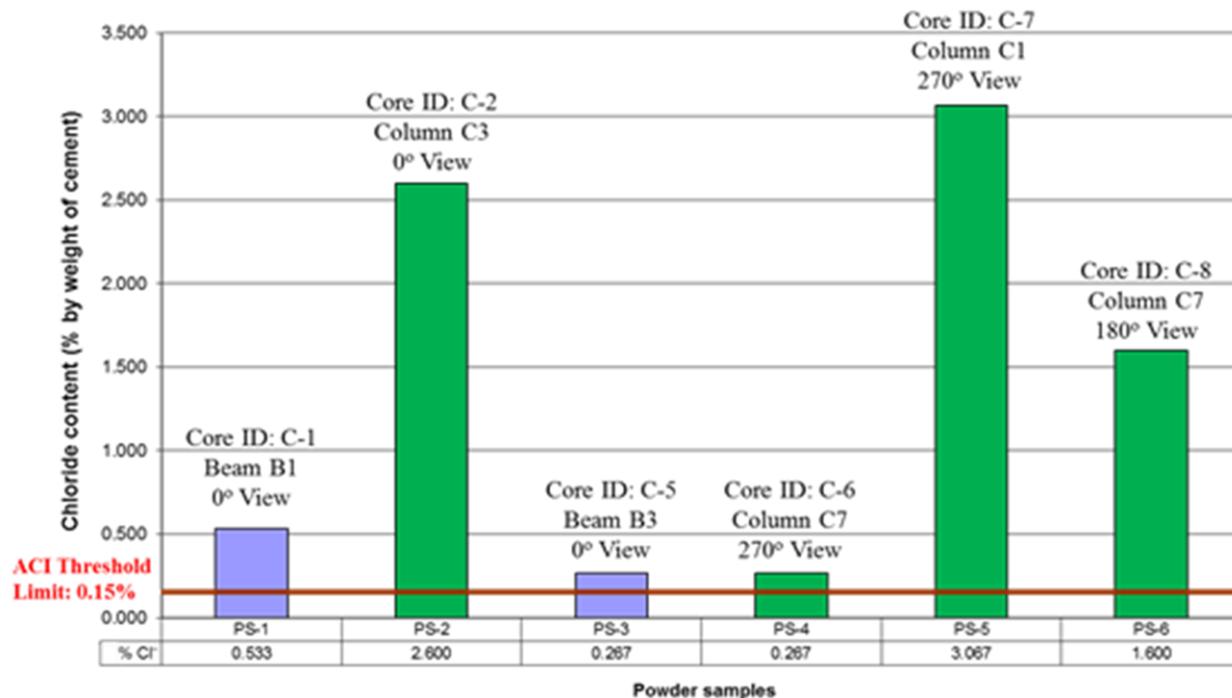
Figure 10. Tabulated Results for Water Soluble Chloride Ion Content Test

Water soluble chloride ion (Cl⁻) tests were performed on six concrete powder samples extracted from the core samples, between 0 to 100mm below the surface of the concrete for the beams, and 0 to 25mm for the columns (due to short length of cores). Results from chloride tests are expressed as a function of the weight of concrete samples or, assuming 15% of cement content, water-soluble chloride (Cl⁻) is computed as a percentage by weight of cement. Water soluble chloride percentage for beams ranged from 0.27% to 0.53% (by weight of cement) and 0.27% to 3.07% for columns. A maximum threshold limit of 0.15% is recommended by ACI (ACI 222R-01 [10]). The tabulated results for water soluble chloride ion content test is presented in Figure 10.

(Cl) content. Water soluble-chloride ion content for the column and beam is found to be in the range of 0.27% to 3.07% which exceeds the recommended ACI threshold by approximately 20 times. Corrosion of reinforcements in the subject structure is likely caused by such high content of chloride ion in the concrete. From the exposed rebars and spalled concrete areas found in columns, it was noted that the reinforcement was badly corroded and the entire cross sections were almost gone. Rust stain and internal cracks and rust stains were also found in the core holes (Figure 11)

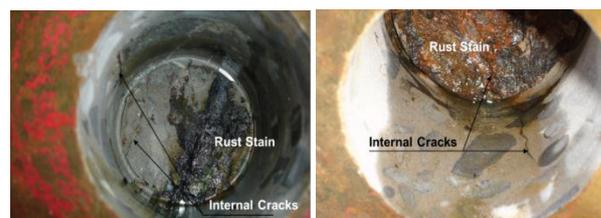
Figure 11. Rust Stain and Internal Cracks Found Inside the Core C-4 and Core C-3 in Location on Column C6 and Column C4, respectively.
