Monitoring the Shear Fatigue Response of Reinforced Concrete Beams Subjected to Moving Loads using Digital Image Correlation

Abstract: A series of three reinforced concrete beams without shear reinforcement were tested to failure under a centre-span monotonic load, a centre-span pulsating load, and a stepwise-moving pulsating load. During each experiment, load-deflection response was continuously monitored and at several stages during the experiment, the load was briefly stopped for crack observations. In addition to this manual crack mapping, more detailed crack mappings were undertaken using the digital image correlation (DIC) technique, employing the open-source DIC software Ncorr. It was shown that while the three beams exhibited a similar mode of failure (i.e. shear), each beam displayed a rather distinctive overall behaviour, particularly with regard to the load-deflection response and the nature of crack initiation and propagation. Results from the DIC analysis are presented to provide direct evidence on the damage progression during the load cycles and discuss the reduced fatigue life exhibited by the beam subjected to stepwise-moving pulsating load.

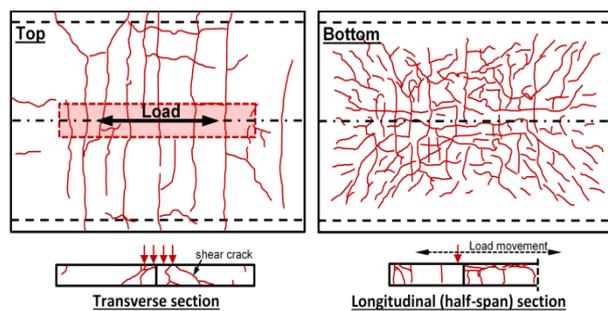
Figure 1. Typical Failure Crack Diagrams for a Bridge Deck Slab Subjected to Moving-wheel Load Cycles. Redrawn from the Diagrams Reported by Matsui in 1984 [5].

Shear fatigue has been the subject of investigation by many researchers and engineers in the past decades. Traditionally, these investigations have been undertaken mainly on reinforced concrete beams, with the cyclic load normally applied at the centre of span. This includes the pioneering works by Chang and Kesler [1], and Taylor [2], who tested a series of reinforced concrete beams without shear reinforcement subjected to varying magnitudes of load, and Farghaly [3] and Okamura et al. [4] who were able to quantify the reduction in the magnitude of shear forces resisted by the concrete under fatigue loading. To better reproduce the influence of moving load on fatigue life, Matsui [5,6] and Perdikaris and Beim [7] led independent experimental studies in Japan and in the US, investigating, respectively, the behaviour of full and 1/6.6-scale reinforced concrete deck models under stationary pulsating and moving loads. They found that a moving load had a more damaging effect than a pulsating load. It was observed that the crack patterns of the bridge deck models subjected to moving loads resembled more closely the crack patterns observed on real bridge decks, characterised typically by a grid-like crack pattern following the orthotropic arrangement of longitudinal reinforcement embedded inside the bridge deck model (see, for example, Figure 1 [5]).

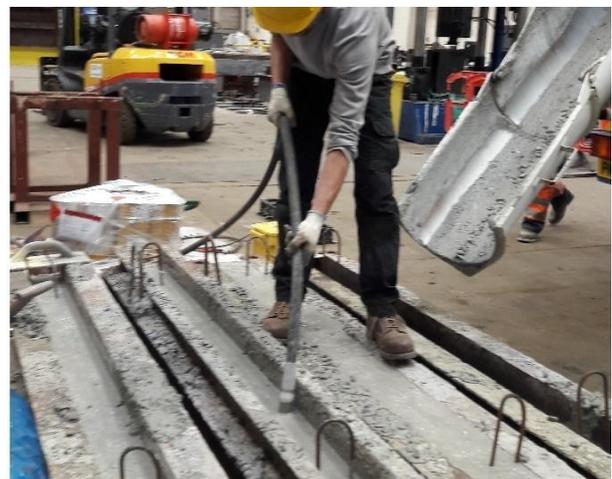
Figure 3. Concrete Compaction During Casting

Upon delivery, the concrete was discharged from a ready-mix truck directly into pre-assembled steel frameworks via a telescopic chute mounted at the back of the truck. The pour was made in two layers, with each layer compacted using a vibrating rod to ensure adequate compaction (see Figure 3). Immediately after compaction, the top surface of the beams was levelled and then covered with a polyethylene sheet. The beams were then wetted daily for further 6 days before the framework being removed for the remaining 35 days. During the latter period, the beams were stored under a polyethylene sheet and wetted twice per week. Daily mean laboratory temperature ranged between 6–13°C. Testing was carried out between 42 and 54 days after casting. The mean compressive strength of the concrete at 49 days was 41.6 MPa; this value has been converted from the mean cube compressive strength which was determined on three 100 mm cubes. The modulus of elasticity and the mean yield strength of the reinforcing bars were 200 GPa and 575 MPa, respectively.

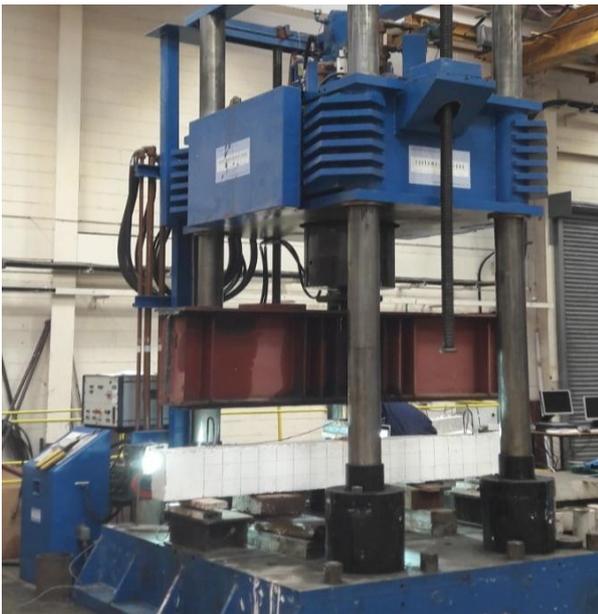
Figure 4. Test Setup Showing Beam 3 during the Preparatory Stage.

Figure 4 displays the overall test setup used in the experimental programme, with the tests undertaken within a servo-controlled Losenhausen 2,000 kN testing machine [17]. In each test, the beam was first positioned below the crosshead of the machine and supported at a distance of 200 mm from both ends to give an overall span of 1,800 mm. Beams 1 and 2 were both subjected to a concentrated load at the centre span. The load for Beam 1 was applied in a monotonic manner under displacement control at a constant rate of 0.2 mm/min, while the load for Beam 2 was applied in a cyclic manner under force control between 14% and 78% of the static capacity of Beam 1. The concentrated load was applied through a $100 \times 150 \times 40$ (thick) mm steel plate and a 300 kN spherical head load cell. Beam 3 was subjected to the same magnitude of load applied to Beam 2; in this beam, however, the load was applied in sequence at five different locations along the beam, each spaced 250 mm apart. This is detailed in the following section.

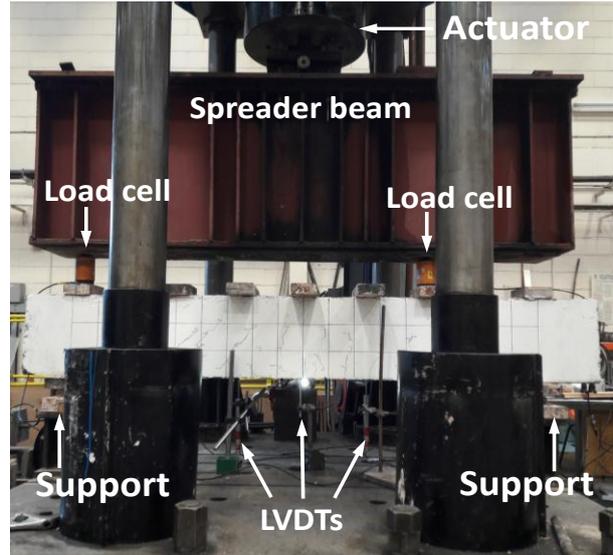
Figure 5. Test Setup Showing the State of Beam 3 at the North Side during Testing. The Supports are Partially Blocked by the Front Columns.

To enable the point load to be applied at five different locations along the beam using only one actuator, the test configuration depicted in Figure 5 was employed. In this setup, a heavily-stiffened steel I section with nominal dimensions of $670 \times 240 \times 2,200$ (long) mm was used. Prior to testing, the steel beam was connected to the upper hydraulic jaw of the testing machine and served as a spreader beam during testing. Below this beam, two 300 kN spherical head load cells were used at a time to ensure stability and equilibrium.

Steps (i) – (v) were repeated until the beam reached its ultimate stage. To simplify this laborious process, seven steel plates with a width of 100 mm and a thickness of 40 mm were pre-arranged at all load points as depicted in Figures 5 and 6; as such, it was only necessary to move the load cell(s) during testing. Hereinafter this load protocol is referred to as a step-wise moving load.

A precision linear variable displacement transducer (LVDT) was placed under the beam and aligned vertically under each load point using a magnetic holder (for clarity, see some examples in Figure 5). These transducers and all the load cells used were connected to a data acquisition system. The data were logged at a rate of 2 Hz.

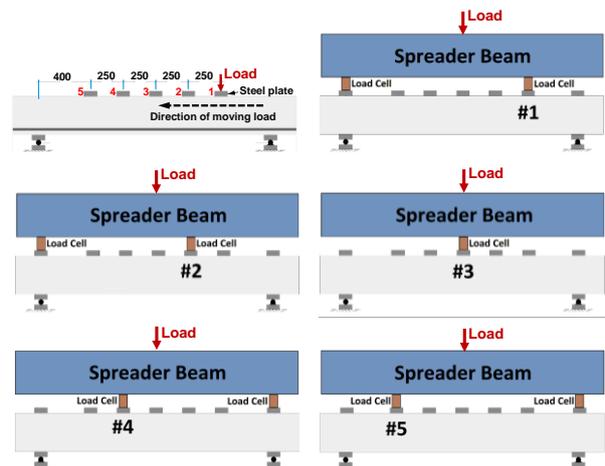
Figure 6. Moving Load Test Protocol Employed in the Test Programme.

- (i) Loading was first initiated by placing one of the load cells at Load Point 1 and the other load cell directly above the left support, as indicated in the schematic in Figure 6. The load was then applied in a displacement control manner to a load of approximately 78% of the capacity of Beam 1 before being fully unloaded.
- (ii) The actuator was then raised a few mm to lift the spreader beam, allowing the load cell on the right to be moved to Load Point 2 while the other load cell was kept in place. The beam was then subjected to same load amplitude.
- (iii) Following (ii), the spreader beam was then raised once again to move the load cell on the

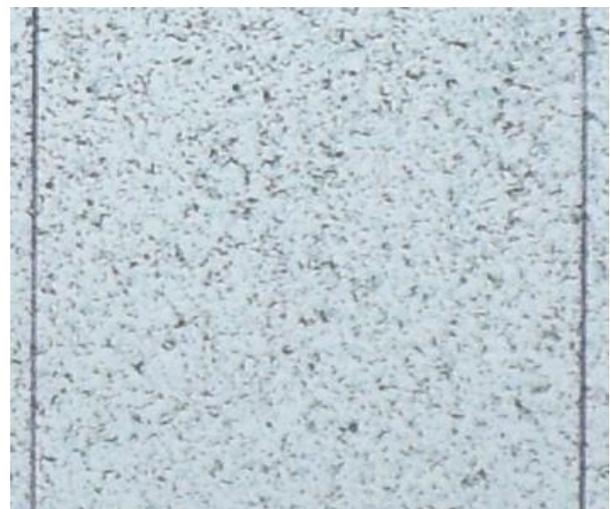
Figure 7. Random Speckled Pattern Generated on the Beam Surface. The Distance of the Vertical Gridlines is 100 mm.

using a dotted-effect black spray paint. It is worth nothing that using this special paint, it was possible to produce a high-quality speckle pattern (in terms of spacing, size, and randomness) over a relatively large surface area ($300 \times 2200 \text{ mm}^2$) in a short period of time (generally less than five minutes). An example of the speckle pattern over an area of approximately $100 \times 100 \text{ mm}$ square is displayed in Figure 7. To minimize the shadow from the surrounding test equipment, three LED lights were used. At the time of testing, only alternating current LED lights were available which resulted into undesirable flickering issues. This limitation will be addressed in a further study.

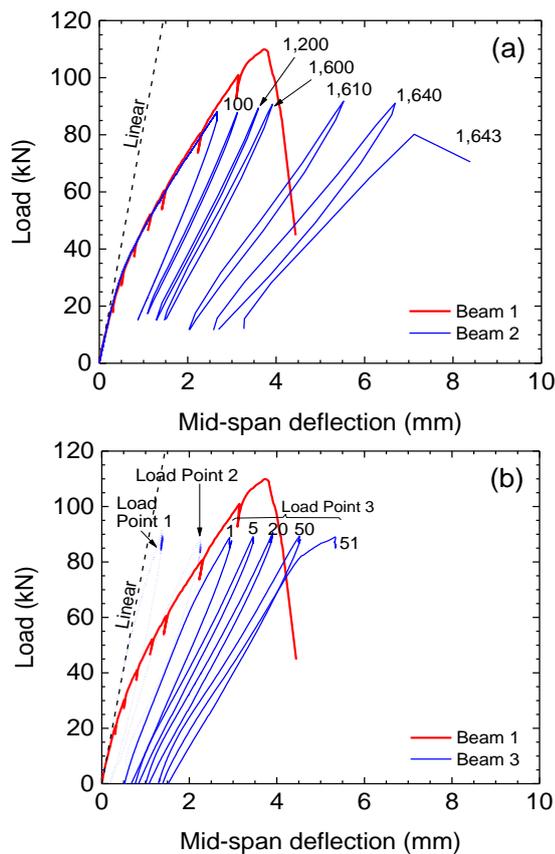
Figure 8. Load-deflection Response of All Beams Tested.

The load-deflection responses for Beams 1, 2, and 3 are presented in Figures 8(a) and (b). Due to the large number of load cycles/passages experienced by Beams 2 and 3 (particularly Beam 2), the responses of these beams are only shown at selected numbers

of load cycles/passages for reasons of clarity. It is apparent from Figure 8(a) that Beam 1 exhibits a typical response of shear-critical beam, characterised primarily by a sudden loss in load carrying capacity upon failure. This occurred suddenly when the load reached 110 kN, which is approximately 30% higher than the load capacity predicted by SNI 2847:2013 [21,22]. Failure was brittle resulted from sudden crack propagation at one side of the beam upward to the point of load application and downward to the support along the bottom reinforcement.

With reference to Figure 8(a), it is apparent that the response of Beam 2 during the first cycle is comparable to that of Beam 1. However, it is interesting to note that when subjected to further load cycles, Beam 2 exhibits progressive reductions in beam stiffness, particularly over the initial 100 cycles. This continues throughout the cycles which indicate damage progression. Both the maximum and residual deflections of the beam also notably increase and are cumulative with increasing number of load cycles which is indicative of damage accumulation. When the applied load reached approximately 1.6k cycles, there was a sudden formation and propagation of diagonal shear crack, causing the beam deflection to increase significantly. At 1,643 cycles, the beam eventually split into two parts in a very brittle manner.

By comparing the load-deflection response of Beam 3 in Figure 8(b) to that of Beam 2 in Figure 8(a), it is clear that moving load introduces a far more damaging effect than the pulsating load. The evidence for this can be particularly seen from the fatigue life of Beam 3 which is almost two orders of magnitude lower than that of Beam 2 (i.e. 51 passages vs 1.6k+ cycles). The fact that moving load has the effect of accelerating fracture and damage processes within the concrete can be traced from the individual hysteresis presented in Figure 8(b). Beam 3 is seen to exhibit a significant residual deflection upon unloading, so as displaying an open hysteresis, most likely due to the formation and propagation of concrete cracking during one load passage. This contrasts with the hysteresis of Beam 2 which generally exhibits a rather close hysteresis (as the beam is loaded and then unloaded, it virtually returns to its original deflection value). Furthermore, the accelerated damage exhibited by Beam 3 at each load passage can also be attributed to the fact that as the applied load moves from Load Points 1 to 5, it has the effect of constantly changing the moment-to-shear ratio (and hence the principal stress orientations at various locations along the beam) [23]. With regards to the pre-existing cracks, the change in principal stress orientations would cause shear stresses to develop across these cracks [23-25] and change sign as the load passes these cracks. It is anticipated that this crack shear reversal would cause two crack surfaces to slide against each other and widen thereby accelerating deterioration. In addition to these two mechanisms, the reduction in fatigue life could also be associated with the increase in shear magnitude as the load moves toward the support [12], although the shear capacity can also be expected to increase as the shear span-to-depth ratio decreases. More detailed assessment on the underlying mechanisms influencing the development and propagation of cracks and the reduction in fatigue life will be reported in a future publication.

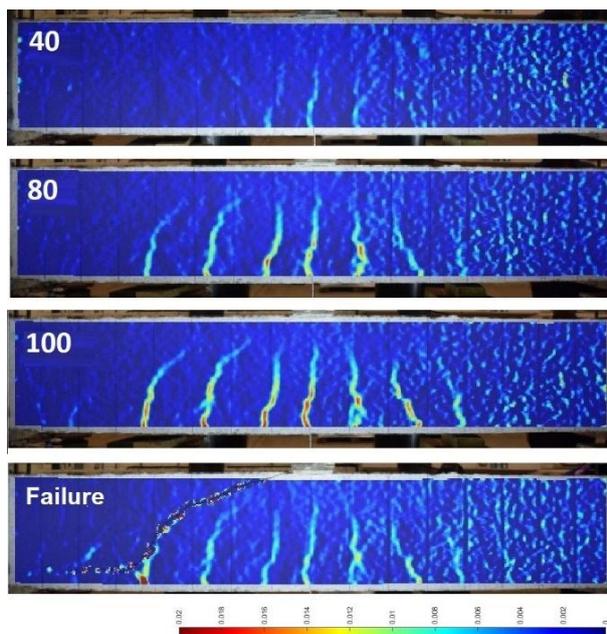
Figure 9. Longitudinal Strain Profiles of Beam 1 Obtained from the DIC Analysis. Numbers Shown Indicate the Load Level in kN. Patches on the Right are Due to Lighting Issues.

To better understand the progress of damage in the test beams, the longitudinal strain profiles obtained from the DIC analysis are presented in Figures 9 and 10. However, given the large amount of results populated from the analysis, only the longitudinal strains of Beams 1 and 3 at selected load levels and passages are presented. From Figure 9, it is evident that the initial cracking in Beam 1 was predominantly flexural. These cracks quickly extended over half the beam depth as the load increased. Some diagonal cracks initiated during the later loading stages and were an extension of the flexural cracks that had developed early. At failure, the top of the critical crack extended to the point of load application, while at the other end propagated downward until it reached the tension reinforcement and continued parallel to the reinforcement, forming a S-

shape crack pattern. This is in line with the failure crack pattern typically found in a shear critical beam with a shear span-to-an-effective-depth ratio of approximately 3.

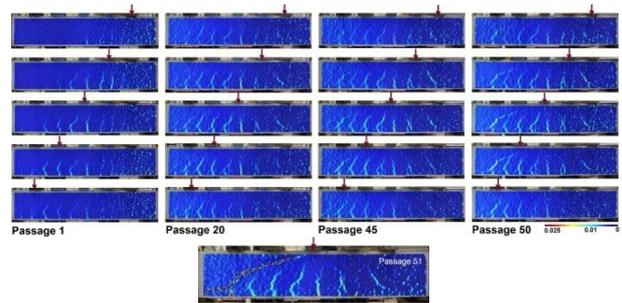
Figure 10. DIC Longitudinal Strain Profiles for Beam 3. Patches on the Right are Due to Lighting Issues.

With reference to Figure 10, it is interesting to observe that in general terms, the crack pattern of Beam 3 takes the same form of that of Beam 1 with respect to the overall pattern and spacing, although the cracks in Beam 3 are seen to develop over a wider area. On closer examination, however, it is interesting to note that the individual crack developed in Beam 3 took a more undulating path than that in Beam 1 and this is likely due to the constant change in principal stress direction as the load was moved from Load Points 1 to 5. As such, during the loading passage, the pre-existing cracks would propagate in different orientations and thereby exhibiting rotating crack tips. It is also interesting to note during the first passage that while the location of the cracks exhibiting greater crack widths essentially follows the location of the applied load, this is not the case in the following cycles as most of the cracks remained open while the load had moved to other locations along the beam. Another interesting feature from the strain plots presented in Figure 10 relates to the progressive development of the diagonal crack over the left span which could be described as shear flexural in nature. It is clear that failure was initiated by two flexural cracks which then developed into a single inclined crack over the mid-height of the web region during the load passage. This occurred when the load was applied at the centre span (Load Point 3) during the 51st load passage.
