Monitoring and Analysis of Coastline Changes in the Coastal Area of Bali Island, Indonesia

Pujianiki, N.N.^{1*}, Predana, I.M.A.¹, Airlangga, K.G.P.¹, Simpangan, G.R.P.A.¹, Osawa, T.², Parwata, I.N.S.³, and Ibrahim, M.S.I.B⁴

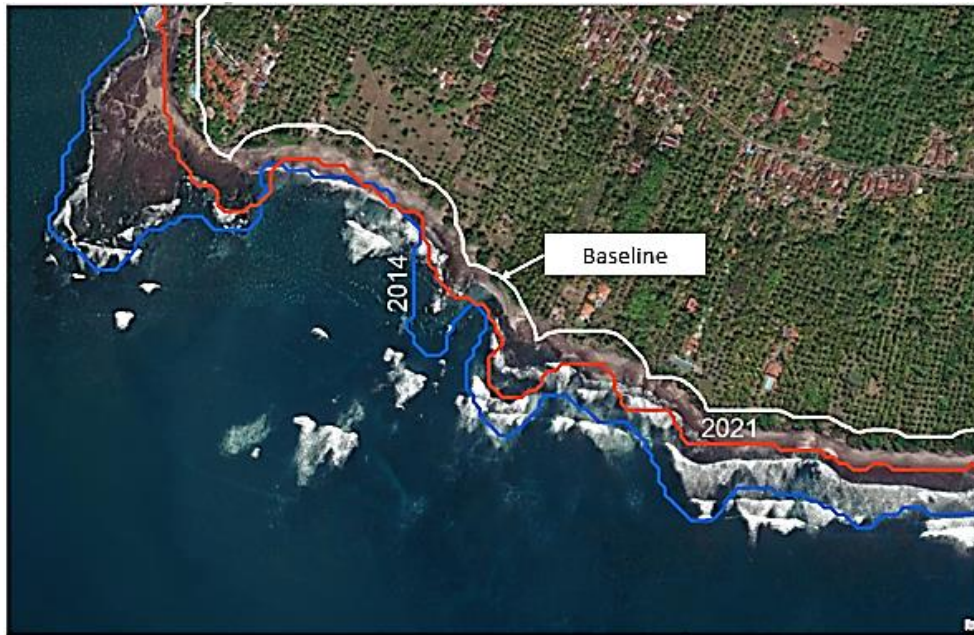
Figure 2. Example of a Baseline (Reference Line) Making Process from Coastline Data for 2014 and 2021

a "buffer" of all shoreline extraction results. DSAS would determine the best baseline for all shoreline data. Figure 2 shows an example of the process for making a baseline (reference line) from coastline data in 2014 and 2021. The baseline line is shown by the white line and the red line indicated the coastline in 2021 and blue line indicated the coastline in 2014.

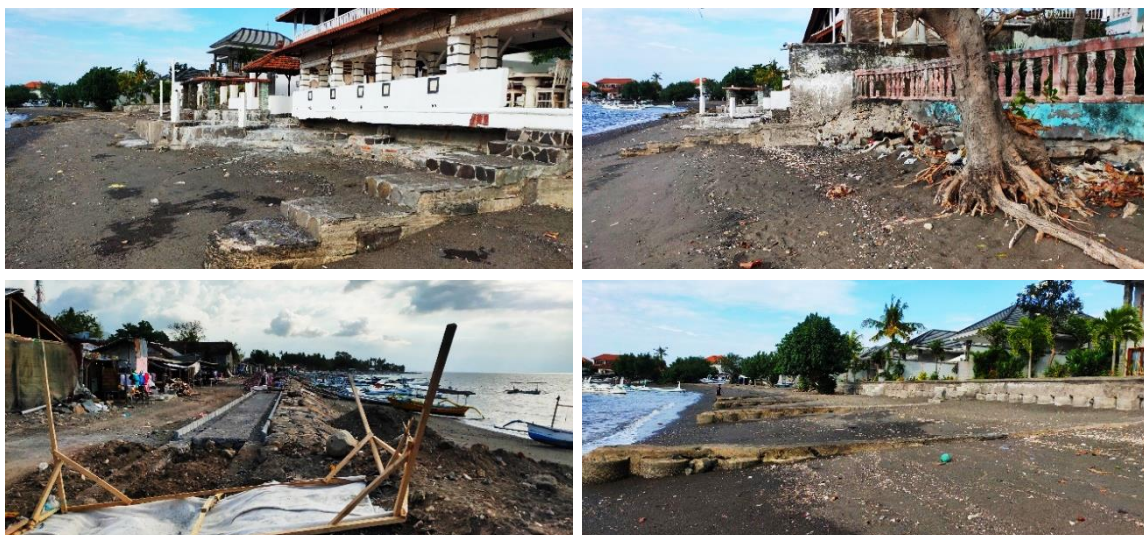
Figure 11. Coastline Survey in Anturan Village, Singaraja, Buleleng Regency

Anturan Village and Camplung Beach location are indicated between Transect ID = 2200 to 2400. The documentation of the field survey conducted on the beach in Anturan Village is shown in Figure 11. On this beach, abrasion is dominant and has eroded several tree roots structures on the beach. The Buleleng regency government seems to have started building revetments to prevent erosion from getting worse. This was proven when the survey team came to the area and observed the process of building revetments and concrete pavement.

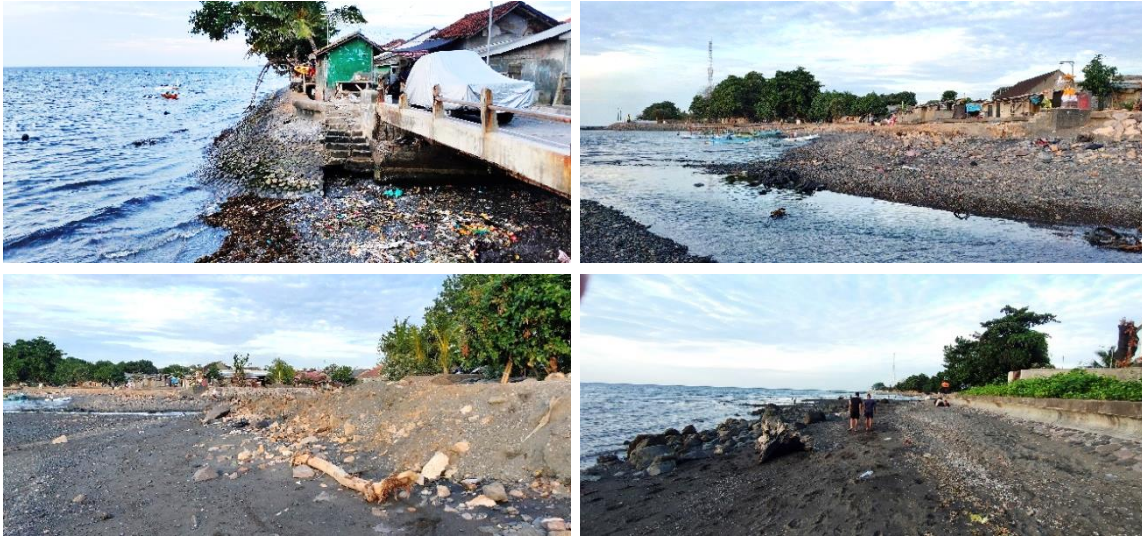
Figure 12. Coastline Survey in Camplung Beach, Singaraja, Buleleng Regency

Furthermore, the conditions at Camplung Beach are shown in Figure 12. Information about abrasion at Camplung Beach has long been reported by the local community. This can be seen from the team's survey results which show abrasion conditions at various points on the coast. Monitoring by the research team points out that there are no signs of beach improvements being carried out by the government.

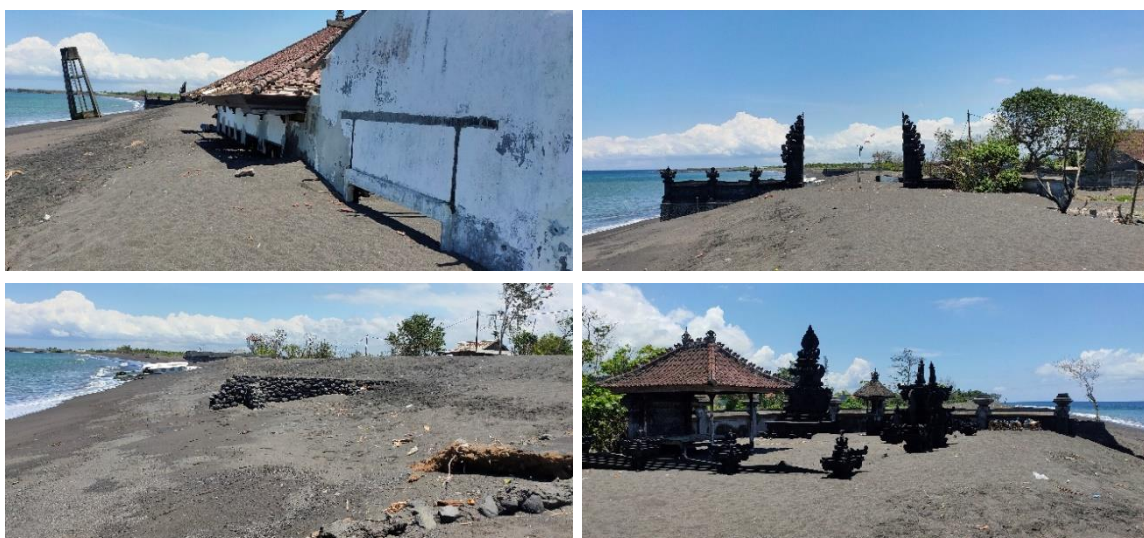
Figure 15. Coastline Survey in Kusamba Beach, Klungkung Regency

The survey location in Klungkung Regency is situated in the eastern part of Kusamba Harbour. The unique condition of this beach is shown by the results of the Sentinel-1 image which identifies the coastline is moving towards land

(abrasion). Conversely, field surveys pointed out sedimentation that has covered half the height of local buildings and temples as shown in Figure 15. This is possibly caused by waves heading towards land and carrying sand material.

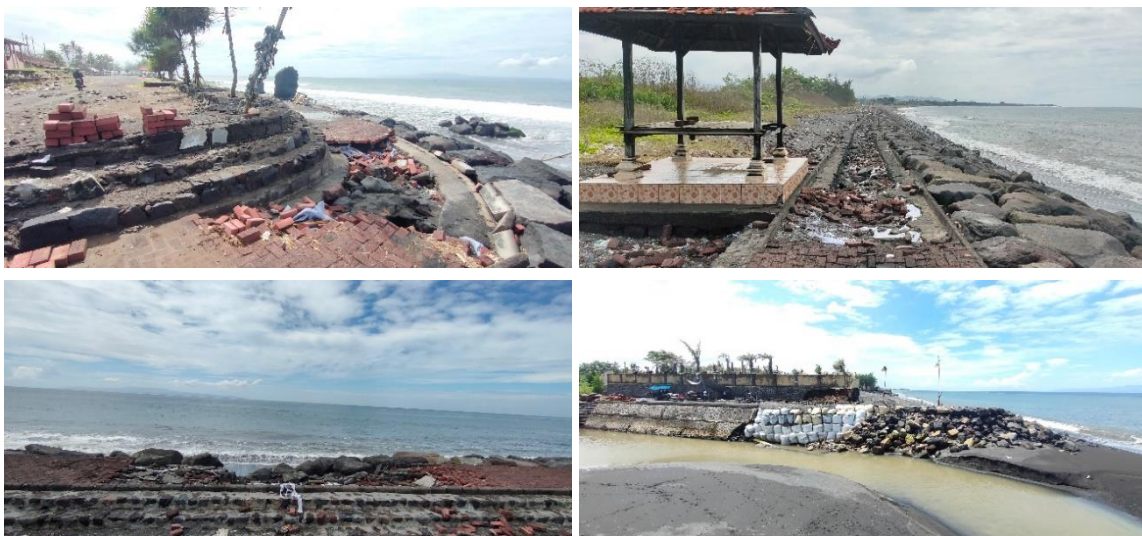
Figure 17. Coastline Survey in Lebih Beach, Gianyar Regency and Its Surroundings

The field survey in Gianyar Regency was focused on Lebih Beach and its surroundings. The research team found that the local government has long taken action to deal with abrasion disasters by constructing coastal protection structures and pavements. However, due to the strong waves on this beach, there was serious damage to the building (Figure 17).

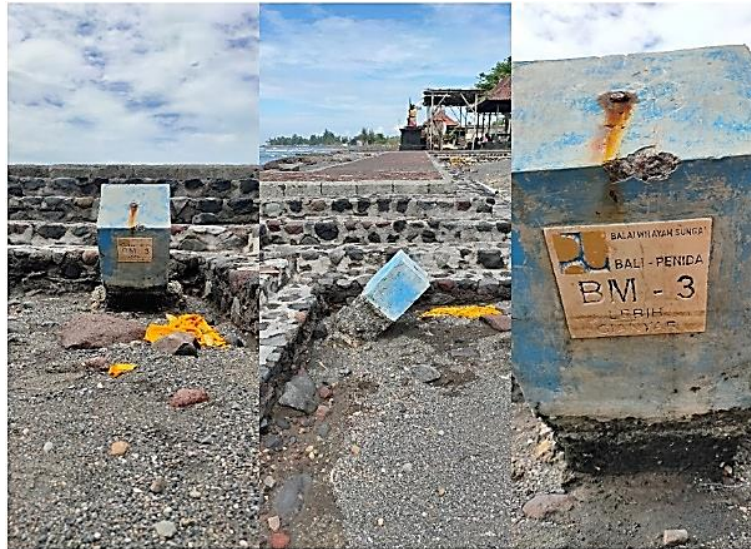
Figure 18. The Condition of the Bench Mark (BM) belonging to the Bali-Penida River Area had Collapsed due to Abrasion

The research team also discovered that the Bench Mark (BM) in the Bali-Penida river area had collapsed due to abrasion, as shown in Figure 18. This proves that the waves that caused the abrasion were very strong. Of course, the BM structure cannot be used as a benchmark anymore because the position and slope have changed.

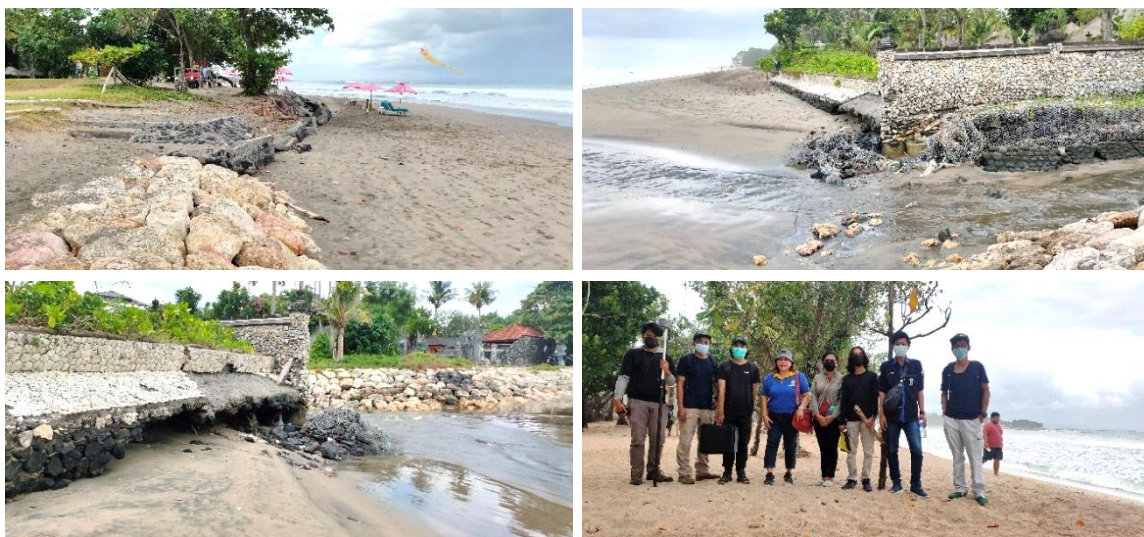
Figure 22. Coastline Survey in Petitengen Beach, Badung Regency and Survey Team Documentation

When data collection was carried out using drones, the research team also observed the Petitengen beach conditions in the field. There are several signs indicating abrasion on this beach as shown in Figure 22.

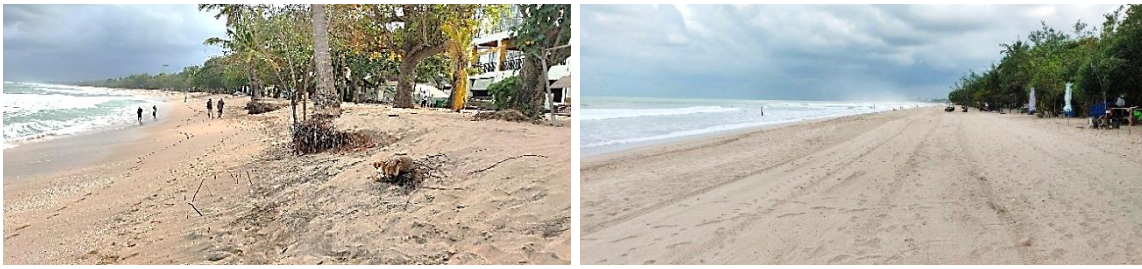
Figure 23. Coastline Survey in Kuta Beach, Badung Regency

Initially, the research team was planning a drone survey to be carried out on Kuta beach. However, after checking the drone track, the team found that Kuta beach was included in the Aviation Security Area. This area is an area that is prohibited for flying drones. Thus, the drone survey was moved to Petitengen beach. On the other hand, the research team made direct observations and found evidence of abrasion and accretion on Kuta Beach as shown in Figure 23.

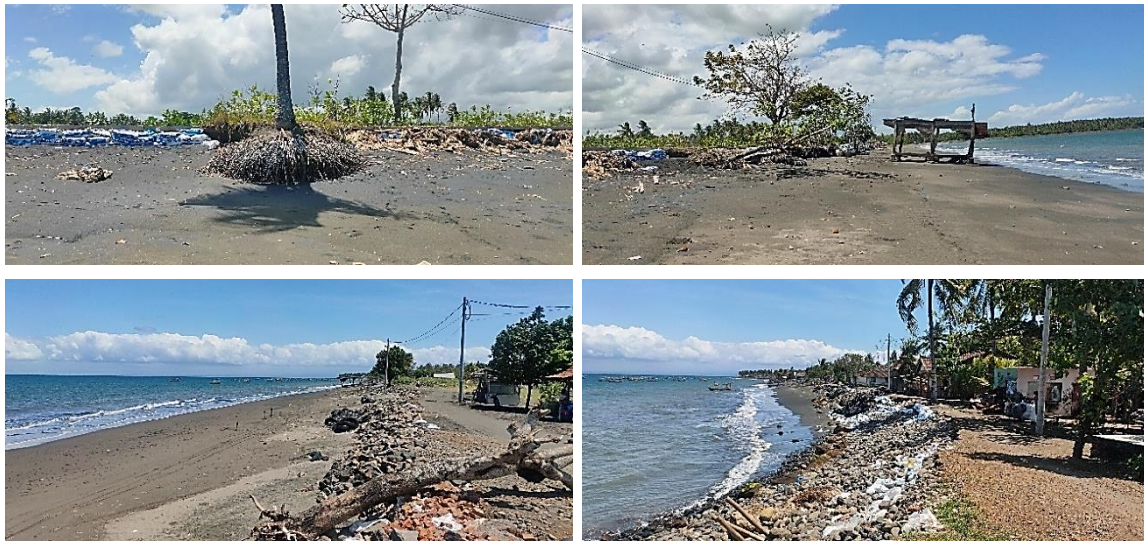
Figure 27. Coastline Survey in Pebuahan Beach, Jembrana Regency

Severe coastal abrasion occurred along Pebuahan Beach. Numerous sections of road were damaged due to this abrasion. Moreover, there were traces of buildings that have been eroded by abrasion and the only structure left was basic construction of the building (Figure 27). There is a high possibility that this abrasion occurred due to the construction of embankments at the Pengambengan fish harbour. Sand material collected on the east coast of Pengambengan harbour should be able to reach Pebuahan Beach if the embankment is not built.

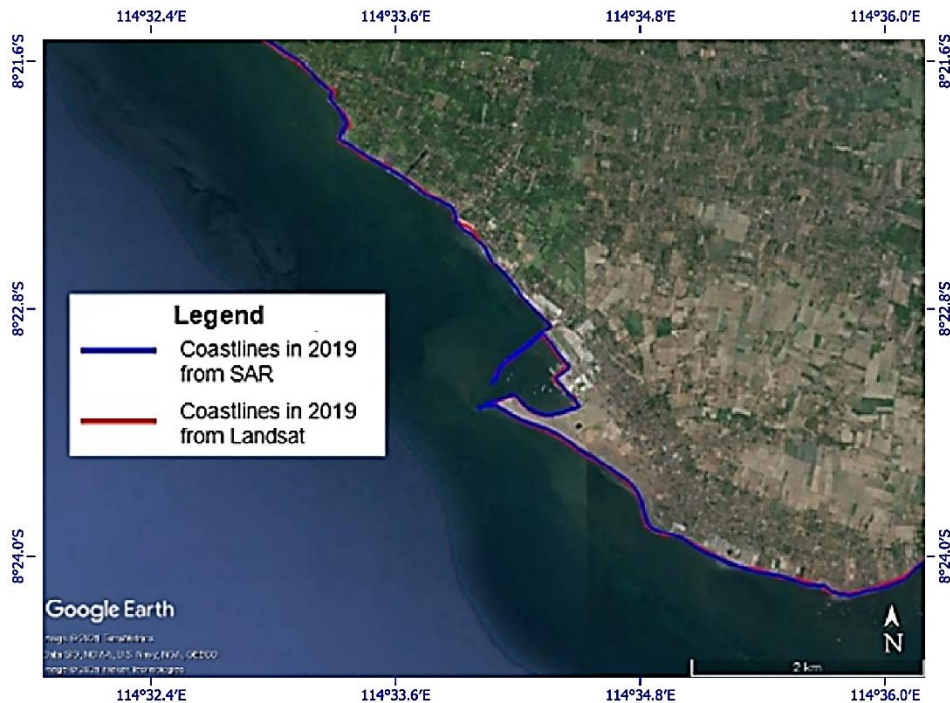
Figure 28. Comparison Results of SAR and Landsat Coastlines in 2019. Landsat Results were Obtained from [44]

For the coastline extraction results in Jembrana Regency, a validation test was carried out with reference data from Landsat 8 results [44]. The comparison results in Figure 28 point out that the two coastlines in general is in a good agreement to define the coastline area. There are some differences at several points, which is most likely due to differences in spatial resolution between Sentinel-1 and Landsat 8 data [47–52].
