# Enhancement of Point Cloud Data for Rock Slope Stability Analysis

Unmanned aerial vehicle (UAV) photogrammetry offers a safe and efficient alternative to manual rock mass characterization in hazardous terrain. This study evaluates quality control measures, compares the discontinuity of accuracy data with and without Ground Control Points (GCPs), and performs kinematic a stability analysis of a sedimentary rock slope. Using a GPS-integrated drone and GNSS coordinates, a high-resolution 3D model was generated in Agisoft Metashape, and discontinuity orientations were extracted using CloudCompare. Results indicate that optimal UAV camera angles and an image overlap of 60%–80% are critical for achieving high model fidelity. Incorporating GCPs significantly improved accuracy; the mean percentage differences in dip direction decreased from 5.21%–22.01% (without GCPs) to 1.66%–10.06% (with GCPs). Comparative analysis with manual scanline surveys demonstrated strong agreement, successfully identifying stable conditions, as well as wedge and planar failures modes. These findings underscore the necessity of GCPs in UAV-based mapping for reliable kinematic rock slope assessment.

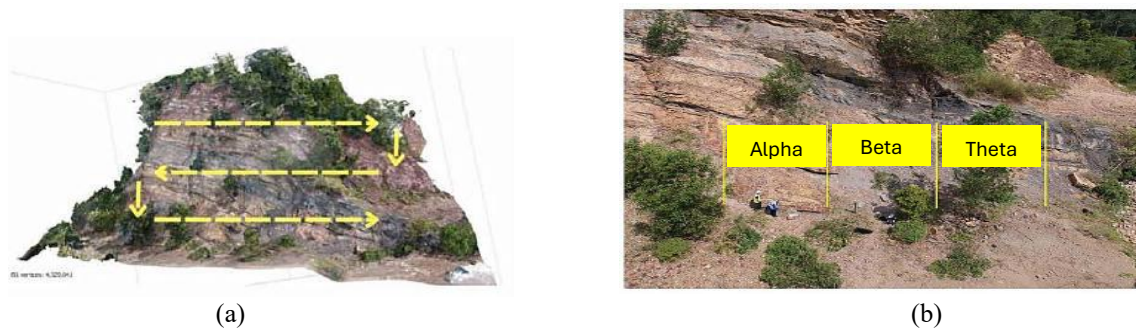
planning for the flight, few factors should be considered, such as flight height, horizontal overlap, flight direction and viewing angle. The study also highlights the importance of sufficient area for flying the drone to capture images of the rock slope surface. Furthermore, the rock slope surface also must be exposed so that the discontinuity is visible and can be seen clearly. This study adopted flight route planning from Kong et al. [19] as a reference. A total of 943 images were taken with a varied flight height from 6–20-meter above the ground and the distance between the surface of the slope with the drone is 5 meters. Figure 3 shows the drone flight path and the three different zones for this study, Alpha, Beta, and Theta respectively.

Figure 3. Photogrammetry Survey: (a) Drone Flight Path, (b) Three Divided Zones

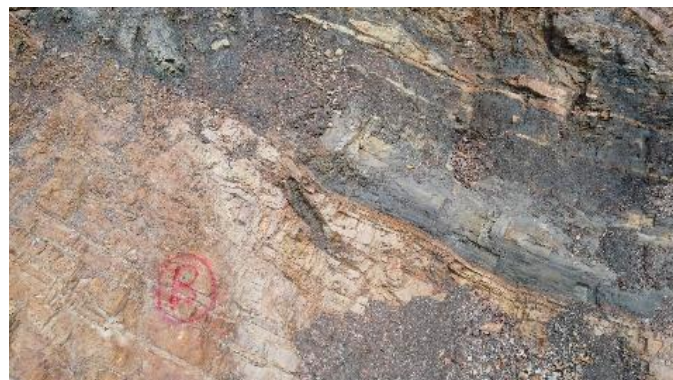
Figure 4. Ground Control Point (GCP) marked on the Slope Surface

Before starting to capture images, three locations had been chosen for marking Ground Control Point (GCP) due to three zones being separated for the sedimentary rock slope. Table 1 shows the coordinates reading of each GCP in longitude, latitude, and altitude by using GNSS Viewer apps from mobile phone. GNSS Viewer (Global Navigation Satellite System, i.e., GPS, Glonass, Beidou, Galileo, IRNSS) displays current GNSS information as reported by the built-in GNSS unit of phone (or tablet). The GCP will be marked by using spray with different colour from the rock slope so that we could identify the location of GCP from the images taken based on Tung et al. [20]. Red colour has been chosen for this site and the GCP were marked as symbol alpha, beta and theta, this mark was shown as Figure 4.

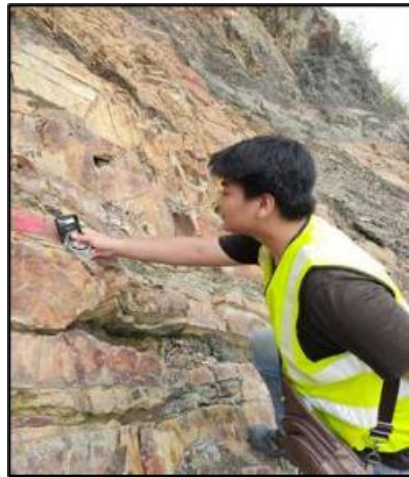
The scan-line technique has been the most often used method for performing a discontinuities survey as established in ISRM [21]. Since the study site chosen was accessible, this approach could be utilized to measure and gather data on discontinuity-related characteristics. According to Tung et al. [20], the slope must be between 30 and 100 metres long. In addition, according to Priest & Hudson [3], the length of the rock slope should be at least 10 to 50 times the average spacing of the discontinuities. The selected rock slope was separated into three zones, and dip and strike measurements were taken solely on the bottom area of the rock slope. The length of the slope of the research area was measured using a measuring tape. The plane orientation of every discontinuity was then assessed using a geological compass, as demonstrated in Figure 8.

**Figure 8.** Measurement of Dip Angle and Dip Direction by using Geological Compass
