Technical Note:

Condition Assessment of the Deteriorated Reinforced Concrete Bridge

Wijaya, G.B.^{1*} and Pacuribot, N.²

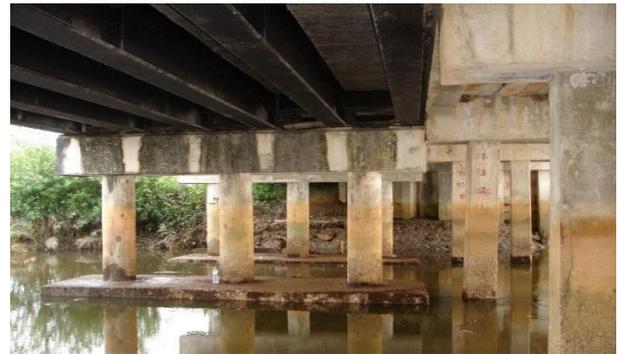
Figure 1b. Bridge Underside View

The column concrete within the top 300mm from the beam soffit was generally in good condition. The concrete in the next 1200mm was in a very bad condition which mostly appeared to suffer from cracks, delaminations, and concrete spalling. The bottom part of the column, which is approximately 500mm from the pile cap, was full of barnacles and appeared to be in good condition.

The beam concrete seemed to be in good condition. Isolated and small areas of delaminated concrete and exposed rebars were found. The underside of the deck slab also seemed to be in good condition as well, except some localized minor delamination, spalling, and exposed rebar.

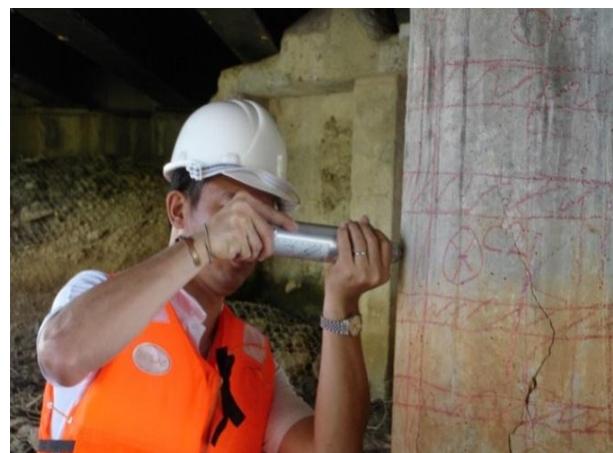
Figure 6. Rebound Hammer Test on Column C3

Twenty three randomly selected locations were tested with Rebound Hammer testing (shown in Figure 6). A total of 230 readings were taken. Interpolating concrete strengths derived from Rebound Hammer manufacturer Data Charts, revealed a mean interpretative compressive strength of 45 to 68 N/mm² and 43 to 56 N/mm² for beams and columns, respectively. A summary of Rebound Hammer readings is presented in Table 1.

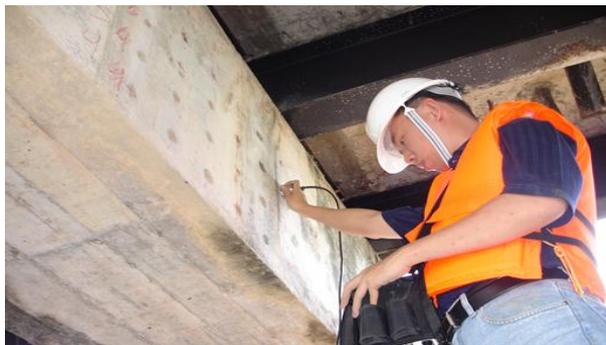
Figure 7a. UPV Test on Beam B4

Stable results were obtained for the beams and most of the columns (with sound concrete) which ranged from 3.20 to 3.61 km/s. UPV Test on Column C2 [UPV 3] and Column C6 [UPV 5] gave very low average reading, which were 1.64 and 0.90 km/s, respectively. These very low results suggested that there could be excessive voids between the two transducers, either caused by the poor compaction of concrete or the concrete are beginning to experience internal separation. In general, the results of these tests show that the concrete samples were in good condition, except for the Columns C2 and C4 where the reading shows very low value. The results of UPV Test are presented in Figures 8a and 8b.

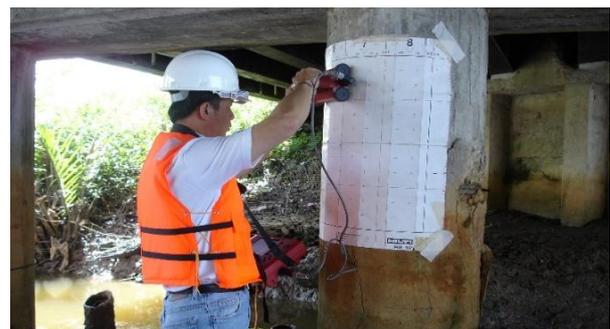
Figure 9a. Pachometer Survey on Column C3

A total of seven locations were surveyed over the columns and beams in the immediate proximity of concrete core locations (Figure 9a). Reinforcing steel bars configurations detected with the Ferrosan instrument were used to determine core locations. Two scans were conducted within the beams, while the five remaining were conducted on randomly selected columns. Results of the survey indicated reinforcement arrangements.

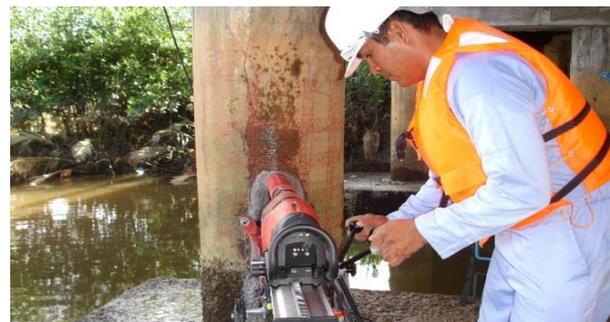
Figure 9b. Core Sample Extraction on Column C4

Eight concrete core samples were collected using wet rotary diamond core drilling techniques on the Bridge beams and columns at selected locations (Figure 9b). Concrete core samples were visually examined and photographed prior to concrete laboratory testing. Concrete Core Data Logs are presented in Table 2. Concrete core holes were patched with shrinkage compensating repair mortar subsequent to sample collection
