# Performance of an Existing Reinforced Concrete Building Designed in Accordance to Older Indonesian Seismic Code: A Case Study for a Hotel in Kupang, Indonesia

**Abstract:** The recent seismic code SNI 1726-2012 is significantly different compared to the older code SNI 1726-2002. The seismic hazard map was significantly changed and the level of maximum considered earthquake was significantly increased. Therefore, buildings designed according to outdated code may not resist the higher demand required by newer code. In this study, seismic performance of Hotel X in Kupang, Indonesia which was designed based on SNI-1726-2002 is investigated. The structure was analyzed using Nonlinear Time History Analysis. The seismic load used was a spectrum consistent ground acceleration generated from El-Centro 18 May 1940 North-South component in accordance to SNI 1726-2012. The results show that Hotel X can resist maximum considered earthquake required by SNI 1726-2012. The maximum drift ratio is 0.81% which is lower than the limit set by FEMA 356-2000 (2%). Plastic hinge damage level is also lower than the allowance in APMC 2001.

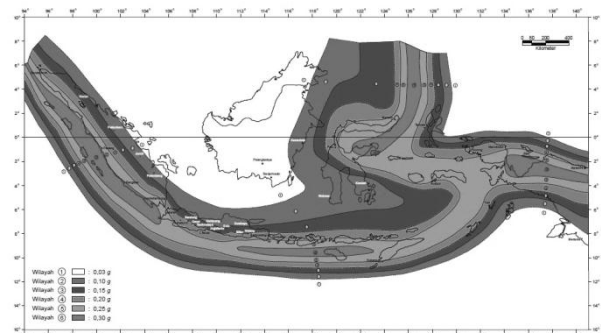
Figure 1. Peak Bedrock Acceleration Map with 500 Year Return Period in SNI1726-2002

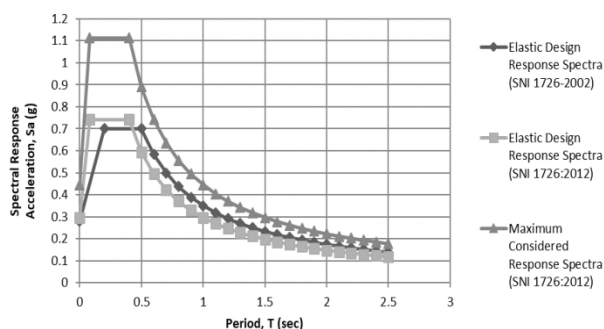
**Figure 3.** Comparison of Acceleration Response Spectra Between SNI1726-2002 and SNI 1726-2012 in Kupang City – Indonesia (very dense soil)

One example of this change is presented in Figure 3, for Kupang city in Indonesia (very dense soil). In Figure 3 the elastic design response spectra in SNI 1726-2012 which is 2/3 of the response spectra of the MCE is compared to elastic design response spectra in SNI1726-2002.

The change of the elastic design response spectrum is not significant in this case. However SNI 1726-2012 introduces different seismic reduction factor. For dual systems structure (reinforced concrete special moment frames and shear walls), the seismic

reduction factor in SNI1726-2002 is 8.5. While in SNI 1726-2012, the response modification coefficient is 7. The resulting nominal earthquake loads (elastic design response spectrum divided by the seismic reduction factor) will differ more significantly. With lower nominal earthquake required in older seismic code, and higher maximum considered earthquake specified by the newer code, building performances designed with the older code are imperative to be investigated.

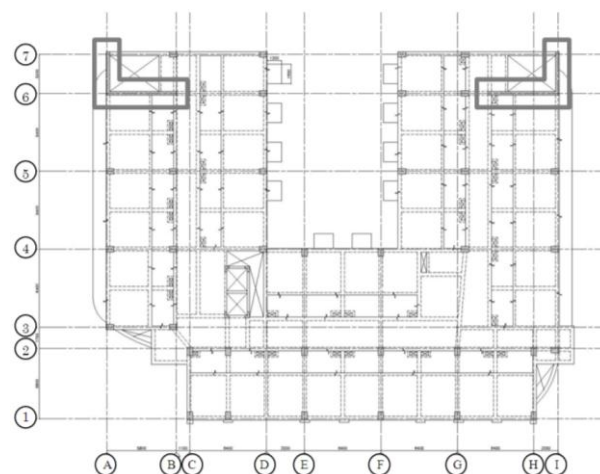
**Figure 5.** Typical Plan View of Hotel X (shown on the 3<sup>rd</sup> floor)

In this study, a six story Hotel X in Kupang, Indonesia with very dense soil site classification is chosen to be investigated. Besides the use of the older seismic code (SNI 1726-2002), the hotel was also designed based on older structural concrete code (SNI03-2847-2002). Indonesian structural concrete code was last updated from SNI03-2847-2002 to SNI 2847:2013 [3,4]. However, there were no significant changes in those structural concrete codes. The elevation and plan views of Hotel X are shown in Figure 4 and Figure 5, respectively. The shearwall positions are marked in Figure 5.

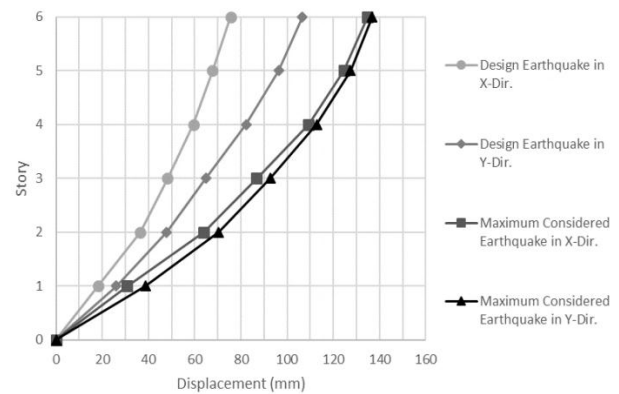
**Figure 6.** Hotel X Displacement Graph

From the analysis results, story displacements, drift ratios, and member plastic hinge damage levels were recorded. Table 3 summarizes the story displacements and drift ratios of the structure in both directions due to elastic design and maximum considered earthquake levels. The same story displacements and drift ratios are also illustrated in Figure 6 and Figure 7, respectively. Moreover, the performance level limits according to FEMA 356-2000 are also plotted in Figure 7. From Figure 7, it can be seen that the seismic performance of Hotel X according to FEMA 356-2000 is very good. Even when the Hotel X was subjected to MCE, the drift ratio still showed Life Safety Performance level in both directions.

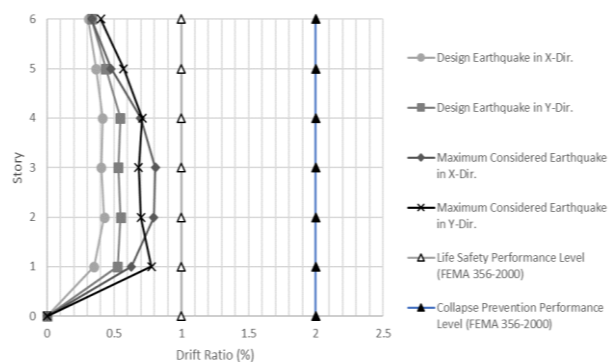
**Figure 7.** Drift Ratios of Hotel X due to Design and Maximum Considered Earthquake Compared to FEMA 356-2000 limits

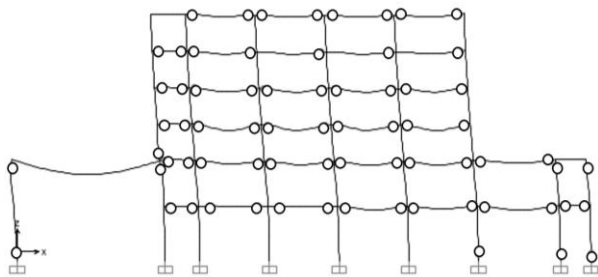
**Figure 8.** Frame 1 Plastic Hinges due to Design Earthquake in x-direction

marked with dotted line boxes, while the beams between the center line of the shear walls to the nearest plastic hinges are in fact rigid beams to simulate the width of the walls. Figures 8 to 11 show the frame damages due to design earthquake and MCE in x-direction, while Figures 12 to 15 show the frame plastic hinge damages in y-direction. Plastic hinge damage marks used in the figures are listed in Table 4, which correspond to the performance levels set by ACMC 2001 (Table 2).

From Figures 8 and 9, it can be seen that the worst plastic hinge damage level due to design earthquake in x-direction is serviceability limit state, which is on

base of the right shear wall. The other plastic hinges on left shear wall, columns, and beams are on operational performance level. For elastic design earthquake, the worst plastic hinge damage level allowed in ACMC 2001 is damage control limit state. Therefore, Hotel X seismic performance due to design earthquake in x-direction is very good.

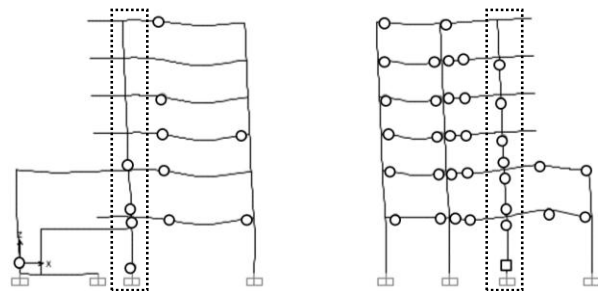
**Figure 9.** Frame 6 Plastic Hinges due to Design Earthquake in x-direction

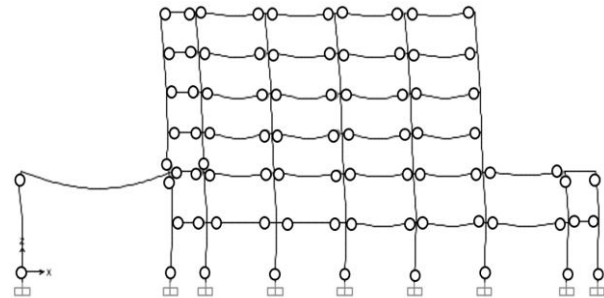
**Figure 10.** Frame 1 Plastic Hinges due to Maximum Considered Earthquake in x-direction

Due to MCE in x-direction, the worst plastic hinge level is also serviceability limit state, which occurs on shear walls and a few beams. All plastic hinges on columns and majority of beams are on operational performance level. All plastic hinges on Hotel X due to MCE in x-direction is lower than the limit set by ACMC 2001, which is safety.

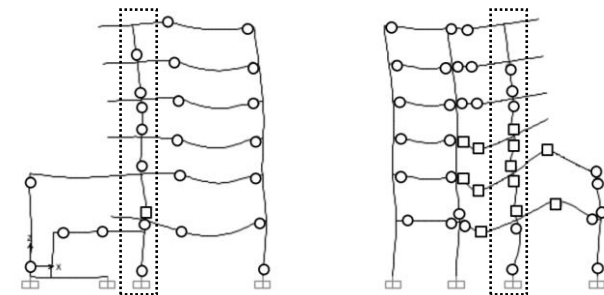
**Figure 11.** Frame 6 Plastic Hinges due to Maximum Considered Earthquake in x-direction

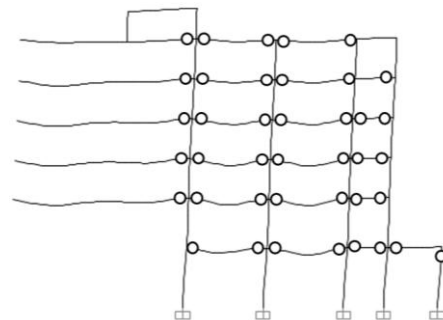
**Figure 12.** Frame D Plastic Hinges due to Design Earthquake in y-direction

The worst plastic hinge damage level due to design earthquake in y-direction is on serviceability limit state, which occurs only on shear wall. All plastic hinges on columns and beams are on operational limit state. That means all plastic hinges on Hotel X due to design earthquake in y-direction is lower than the limit set by ACMC 2001, which is damage control limit state.

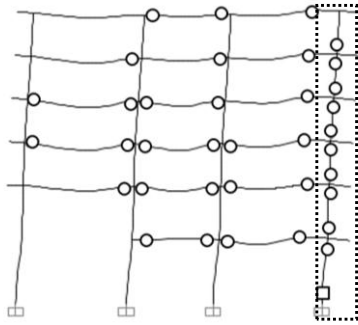
**Figure 13.** Frame I Plastic Hinges due to Design Earthquake in y-direction

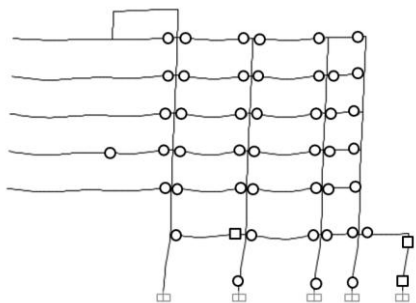
**Figure 14.** Frame D Plastic Hinges due to Maximum Considered Earthquake in y-direction

From Figures 14 and 15, it can be seen that majority of plastic hinges on Hotel X are on operational

performance level. While a few plastic hinges on shear wall, columns, and beams are on serviceability limit state. As mentioned above, the worst seismic performance level allowed by ACMC 2001 due to MCE is safety. Therefore, Hotel X seismic performance level due to MCE in y-direction based on plastic hinge damage level is satisfactory.

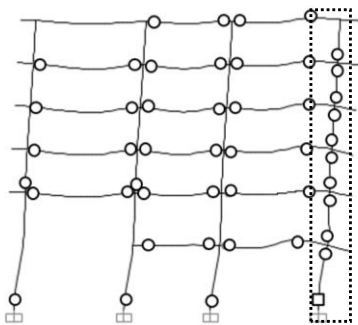
**Figure 15.** Frame I Plastic Hinges due to Maximum Considered Earthquake in y-direction
